ILA-USMX JOINT SAFETY COMMITTEE

OSH ALERT 2019-14 [02 December 2019]

Crosby 7/8” Shackle Notice

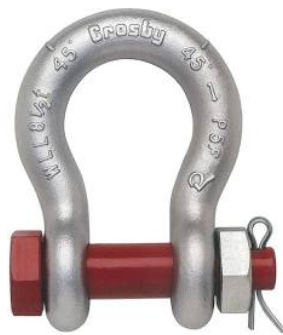
In sum, the 7/8” shackles set out in the alert have been found to have an ultimate (breaking) load somewhat below that published within Crosby’s product catalog.

The effected shackles are of the 6.5 Ton variety, and each have a product identification code (PIC) of **5VJ** embossed on the shackles’ bow.

Crowley urges that: ***“The shackle bow may have a previously undetected defect, and continued use may result in loss of load, property damage, severe injury, or death.”***
