ILA-USMX JOINT SAFETY COMMITTEE

OSH ALERT 2020-17 [13 October 2020]

Industrial Truck Mast Connection Failures

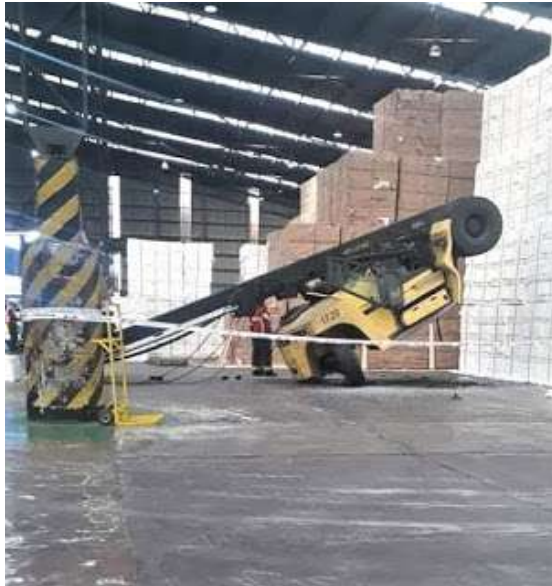
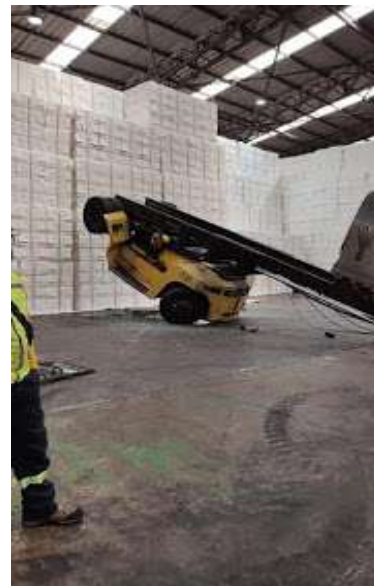
The ILA~USMX Joint Safety Committee (JSC) has taken note of a series of fatal accidents occurring at foreign ports, wherein the operators of industrial trucks have been crushed by the failure of mast connections with the resultant collapse. The last occurred at Puerto Coronel, Chile just last month (23 September). We provide a link that provides further information about that accident: <http://www.blueoceana.com/?p=4719>

We also know that a globally operating marine terminal operator has issued guidance to its management that increased visual inspections of stress points (supplemented by dye penetrant examinations) should be carried out on such equipment.

In the meantime, we urge increased diligence on the part of management, maintenance staff and operators to redouble your efforts in the daily inspection of industrial truck stress points/connection points as we work to foreclose on similar incidents occurring at ports within our jurisdiction.
