## ILA-USMX JOINT SAFETY COMMITTEE

] OSH Circular 2016-10 (25 October 2016)

### Container-Over-Container Clearance

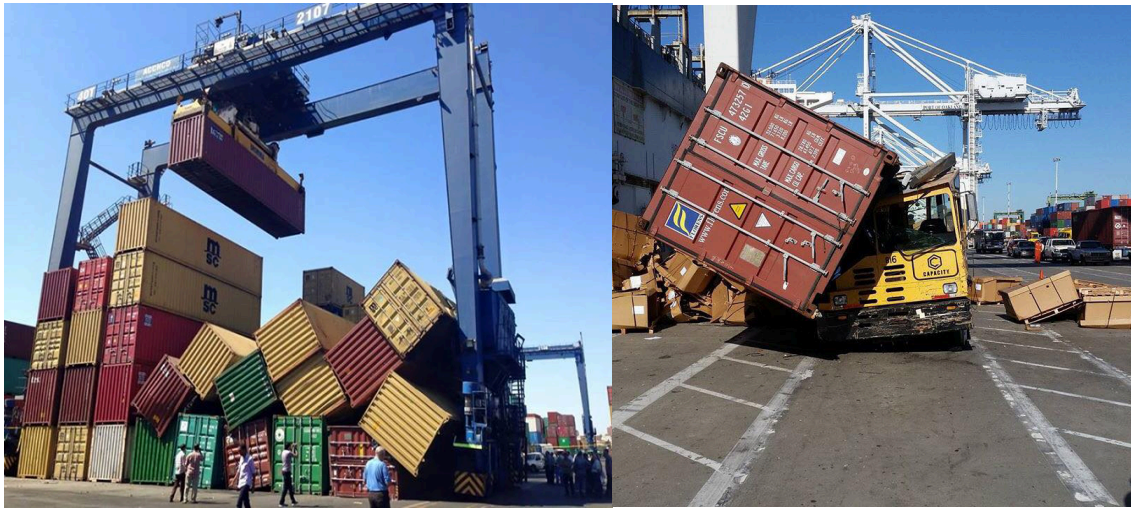
Globally, The ILA~USMX Joint Safety Committee has observed an increased incidence of stowed/stacked containers that are knocked out of position (toppled) by another container being trolleyed along the bridge of ship to shore or yard gantry cranes (RTGs).

In nearly every such case, the root cause ended up being the operator's failure to ensure that the container he/she was moving horizontally had sufficient enough height to clear the adjacent, stationary stack(s).

While there are different means to limit the risk in such operations, such as artificial intelligence software programs; procedures to prevent vehicles and individuals from positioning themselves "in the bight", and planning the stacks to minimize hoisting up and over... they are not, in our experience, always effective or practical. In all cases, however, the operator should exercise caution when hoisting, lowering, trolleying and gantrying... and should always move at a safe, controlled speed regardless of any other controls that may be in place.

Vehicle operators and workers & managers obliged to be in close proximity to hazards such as those shown in the photographs above, should always be alert to those potentials and should exercise the wisdom of staying at least one container length in front of (or behind) the potential path of an upset,
